Should you have questions at any time, Merit Medical offers a 24/7 dedicated Aspira Medical Services & Support line at 833-3ASPIRA (327-7472).

Aspira Valve Replacement Instructions

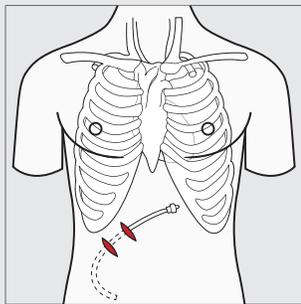
Peritoneal Catheter Tunneling Technique

Peritoneal catheter is tunneled downward rather than superior and medial to the insertion site. Catheter exchange is required. Refer to tunneling instructions below as well as the Aspira Peritoneal Drainage Catheter Instructions for Use to ensure proper tunneling technique.

Make an incision at the desired catheter insertion site. Make another incision superior and medial to the insertion site at a distance selected for tunnel length (generally 5–8 cm)

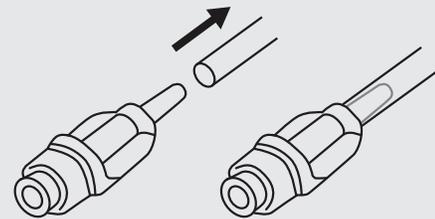
5. Advance the catheter over the new valve stem past the shoulder on the valve.

NOTE: If the catheter and new valve are connected and then disconnected, trim the proximal end of the catheter and attach a new valve to ensure a secure connection.
